# Drilling report

## Delftse Hout multipurpose research borehole

Delftse Hout multipurpose research  
borehole

DAPGEO-02

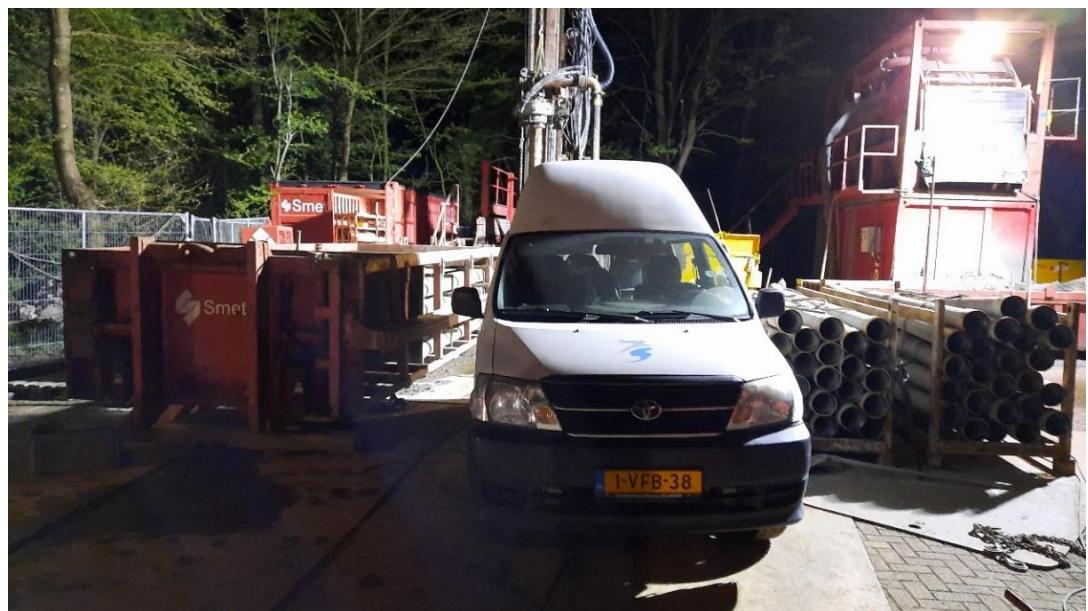
Figure 3.1: Impression of the logging setup in phase 3.

For phase 3 a total of 5 logging tools were used. The continuous logging activities together took about 24 hours. On March 26 in the evening (Figure 3.1), the deviation logging started using the Century 9622A tool. Logging speed did not exceed 9 m/min and the tool was not centralized.
